# **Preliminary Analysis on the Evolution of Mosque Sakhi Sultan Shah Ali Akbar's Complex Suraj Miani Multan**

**Muhammad Naeem Khalid, Tariq Mahmood, Jahanzaib Qamar**

Department of Architecture, University of Southern Punjab, Multan, Pakistan

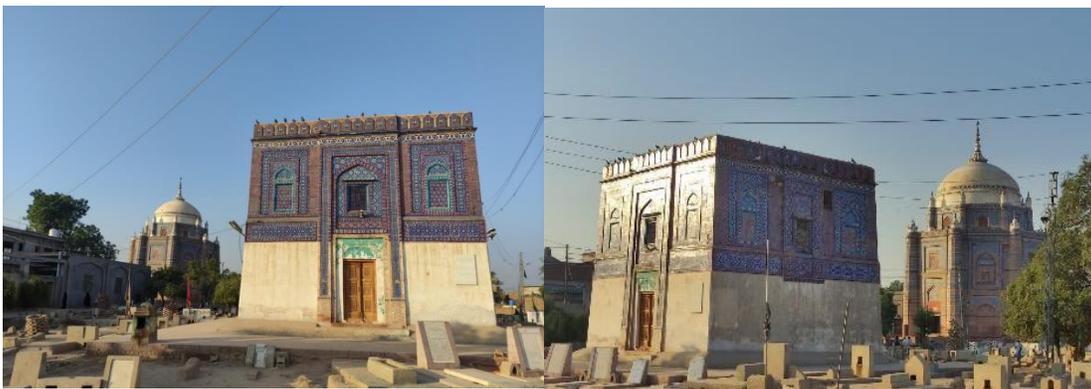
**Figure 1.1 Shows the Complex of Sakhi Sultan Shah Ali Akbar. Source: Author**

aspects of Multan, had a magical impact on the viewer’s eye. The use of the octagonal shape, tapered buttresses located at each corner of the octagon, resembles the Shah Rukn-e-Aalam tomb architecture style. The main structure of the tomb of Sakhi Sultan Shah Ali Akbar has an octagonal-shaped base, drum, and a hemispherical dome. The main entrance of the tomb has Quranic inscriptions, which are considered an example of beautiful calligraphy. The mother’s tomb of Sakhi Sultan Shah Ali Akber has a Square shape structure with tapered walls having a single door towards the south for the entrance to the tomb, slightly raised over a platform with a little flat dome. The lower half of the tomb has only plain lime plaster, while the other upper part has blue tiles Fig. 1.1.

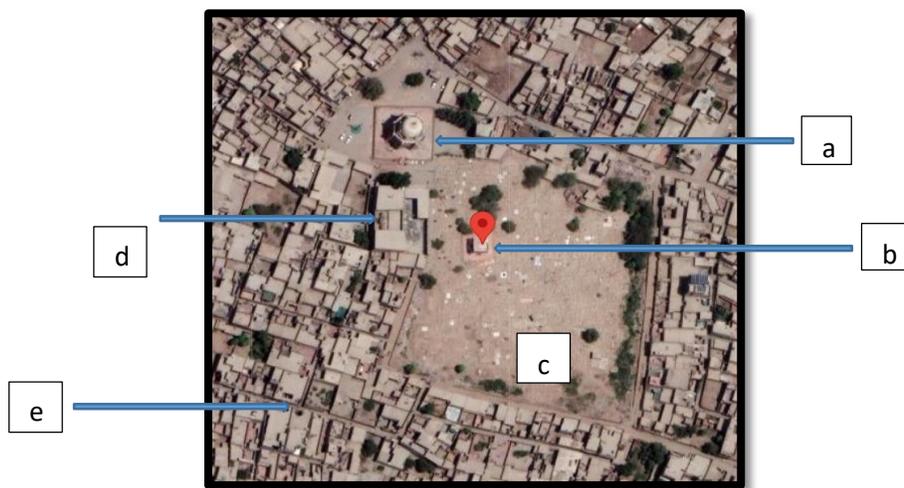
**Fig 1.2 Location Plan of the Complex (Satellite Map Taken on 01 Jan 203 Site Location 23.217339, 71.438454'E)**

The complex is located in the heart of the city of saints, it is located on the road named Soraj Miani Road and Soraj Miani Mohallah. The surrounding area consists of residential areas and some famous graveyards, and this area is also famous for Imam Bargahs.

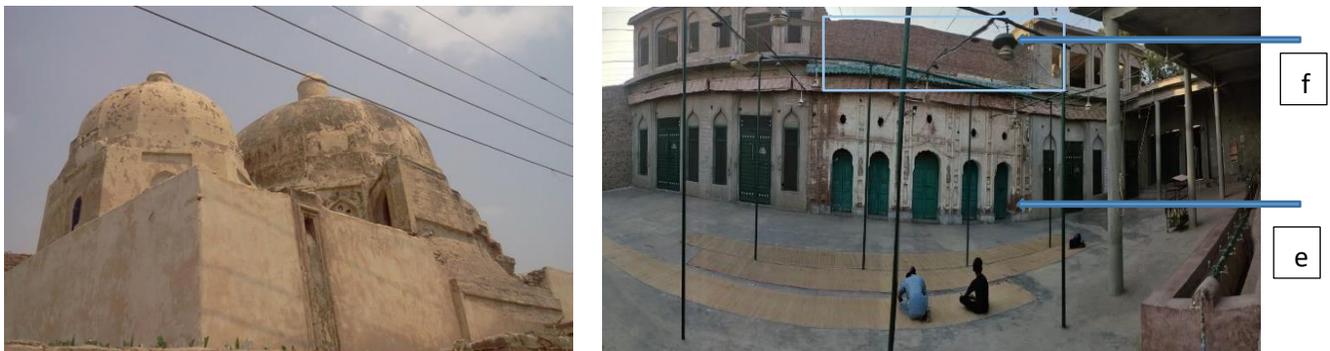
**Fig 1.3 Old Picture of Historic Mosque (Left) (Courtesy of Mapio.net), Exterior Front Picture Taken on 22-11-2022 of the Mosque of Sakhi Shah Ali Akbar (Right) Source: Author**

In Figure 1.3 (left), it is evident that the original, historic portion of the mosque has suffered significant damage, and new additions have been made alongside the original structure, as shown in Figure 1.3 (right, part "e"). Rather than preserving the historic mosque with respectful conservation methods, similar to those used for other monuments within the complex, the mosque has undergone new interventions and expansions. These changes, aimed at increasing the mosque's area, have disregarded its historical and contextual integrity within the complex. The additions, constructed using concrete and cement plaster, have completely compromised the aesthetic and historical significance of the original structure. Currently, the old historic mosque comprises the central section, shown in Figure 1.3 (right, part "e"), featuring five doorways,

while the existing domes are concealed behind a recently added parapet wall, depicted in Figure 1.3 (right, part "f")

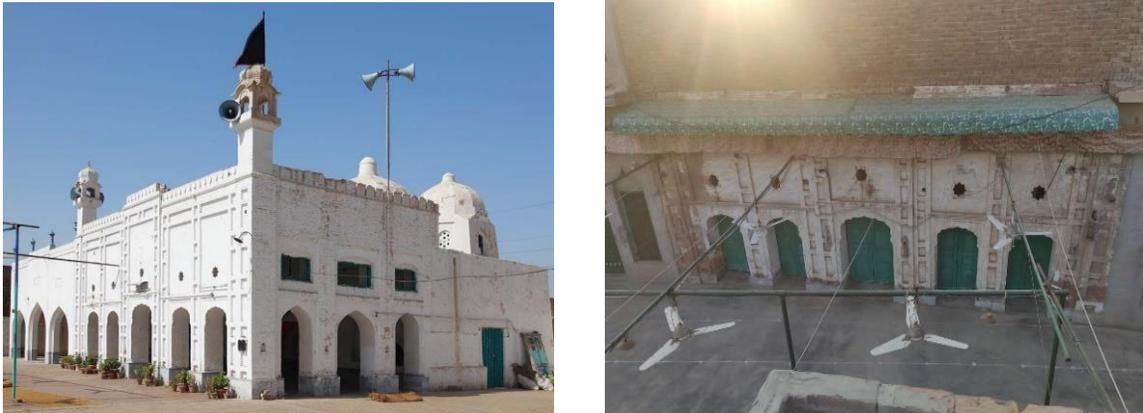
**Fig 1.4 Comparison of Old (Left) (Courtesy of Mapio.net) and Present (Right) Picture of Mosque Taken on 22-11-2022. Condition of the Mosque. Source: Author**

The front minarets on the eastern side, visible in Figure 1.4 (left), once held significant importance as architectural elements of the mosque. Unfortunately, they have been destroyed, and new structures have been added to the northern and southern sides of the mosque, as shown in Figure 1.3 (left). In continuation of the historic structure, several modifications have been made that undermine its authenticity. The original wooden doors have been replaced with local steel doors, and the traditional plaster has been removed and replaced with cement mortar. However, a portion of the mosque still retains its original mud-husk plaster, which can be observed on the interior of the arched doorway at the entrance (Figure 1.6). This original plaster, though still intact, is gradually deteriorating due to a lack of preservation efforts, as shown in the accompanying images.

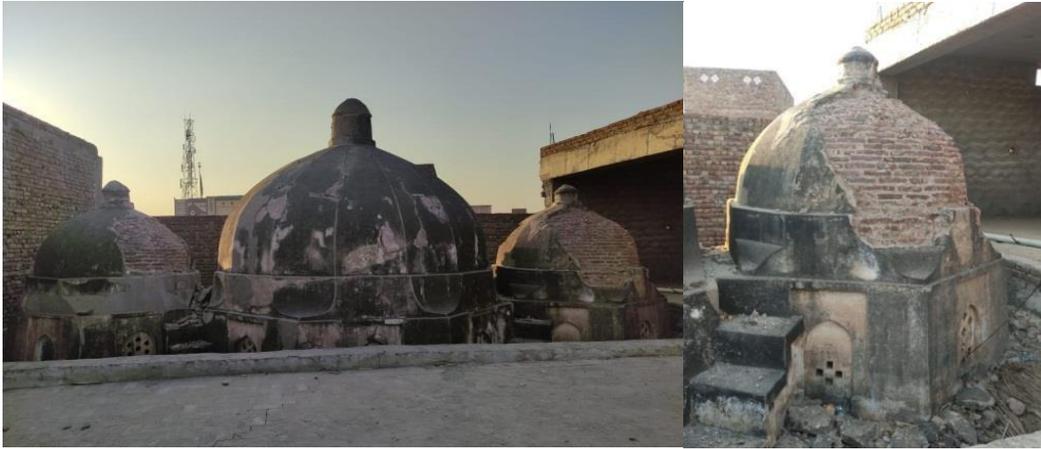
The domes, once glorious representations of Islamic architectural beauty, are now in a critically deteriorated state. The outer surfaces of the domes have been severely damaged due to a combination of natural and human-made factors. This decline is largely attributed to a lack of knowledge, negligence, and the community's disregard for the historical significance of the structure. Additionally, new structures added to the northern and southern sides have further detracted from the mosque's original architectural context.

The domes, as shown in Figure 1.5, are integral structural elements, serving as load-bearing components of the mosque. Their sizes differ, with the central dome being the largest and the two side domes smaller. However, all three are rapidly deteriorating due to the community's careless approach to preserving the monument. The lower layers of brickwork and the poor condition of the plaster are clearly visible, highlighting the urgent need for restoration to protect these historically significant elements.

**Figure 1.5 represents the Present Condition of the Domes' Exterior. Source: Author**

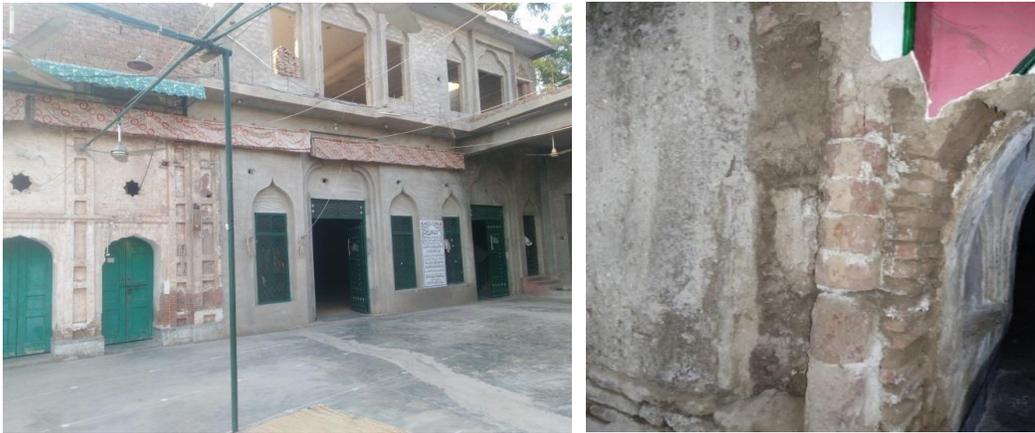
**Fig 1.6 The Present Condition of the Mosque, Addition of Steel Doors and Windows (Left), Interior, A Corner of the Arched Door Way and the Material Condition of the Historical Structure (Right). Source: Author**

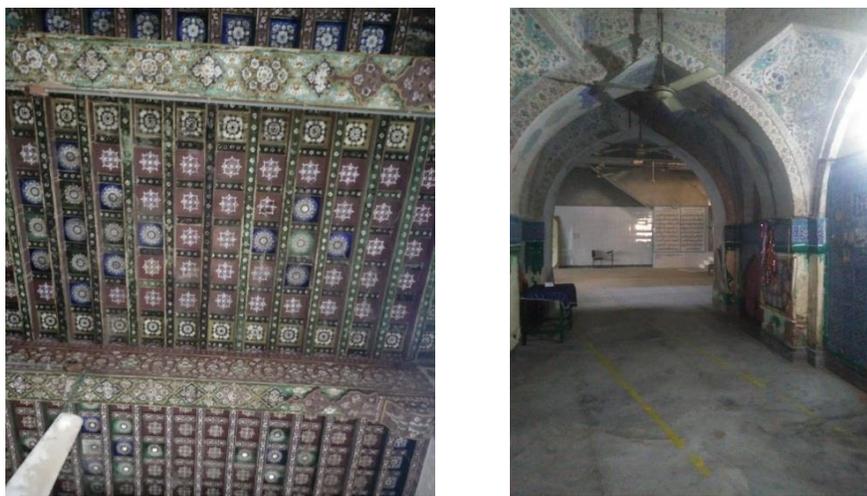
The interior of the mosque is a remarkable masterpiece of the architectural craftsmanship of its time. The ceiling of the front verandah is adorned with intricate floral patterns carved into wood, showcasing exceptional artistry. These patterns are further enhanced by the use of vibrant colors, adding to the visual appeal and elegance of the roof. The use of wood in the ceiling, combined with the detailed carvings and colorful designs, significantly enhances the overall beauty of the mosque's interior.

**Fig 1.7 Kashikari in the Ceiling of the Verandah (Left), an Interior View of The Domed Hall (Right). Source: Author**

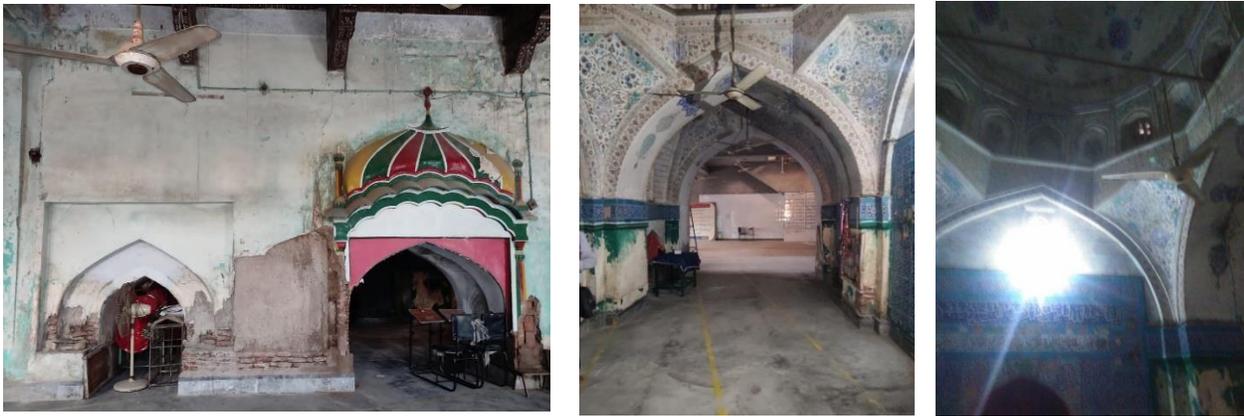
Unfortunately, the floor of the main domed hall has been raised, altering the original scale and proportions of the architecture. This change has rendered the central arched doorway difficult to use for entry, as one can no longer pass through in an upright position (Figure 1.8, left). However, the added arches on the north and south sides of the mosque provide sufficient access to the domed hall (Figure 1.8, right).

**Fig 1.8 The Inside View of the Mosque from Verandha Toward Domed Hall, West Side (Left) and View from Domed Space Hall Towards North (Right). Source: Author**

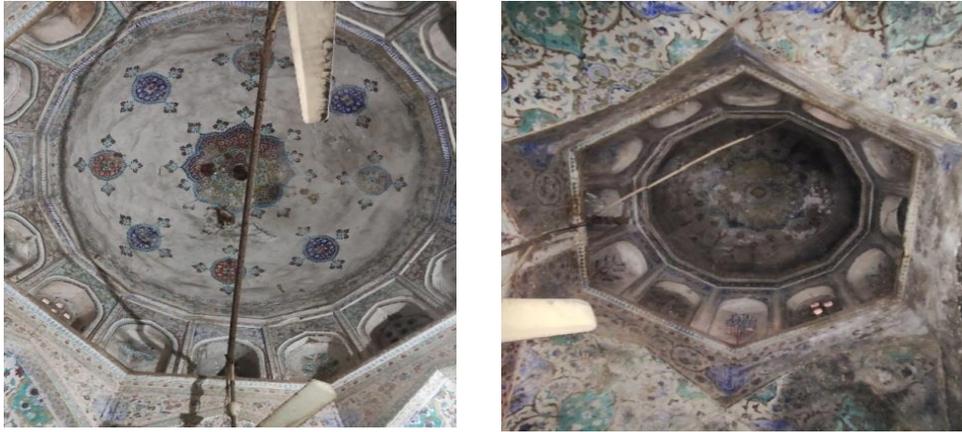
The interiors of the domes are exquisitely adorned with intricate patterns and kashi gari (traditional tile work), showcasing a variety of designs that elevate the aesthetic appeal of the domes. Floral patterns are a prominent feature of the decorative elements used in the dome interiors, adding to their artistic charm. These intricate designs significantly enhance the beauty and visual impact of the mosque's domes, reflecting the rich craftsmanship of the era.

**Fig 1.9 Interior view of the domes, the central large dome (Left) and the smaller side dome (Right) of the Mosque. Source: Author**

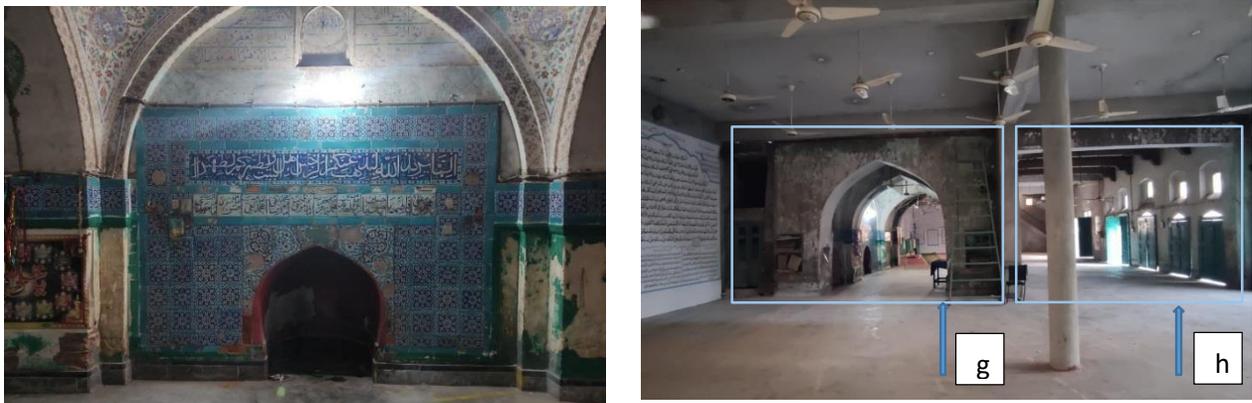
As previously mentioned, the domed prayer hall is divided into three sections, each topped with a dome and connected by arched gateways (Figure 1.8, right), which provide access to the newly added structures on the north and south sides. The change in floor level is evident in Figure 1.10 (left), where only the upper part of the mehrab is visible, while the lower portion is obscured due to the raised floor, which was adjusted to align with the side halls (Figure 1.10, right). This alteration in the floor level has significantly affected the functionality and historical integrity of the mehrab, rendering it unusable as a focal point for the imam during prayers.

**Fig 1.10 West Facing Mehrab (Left) and Interior Arch Way (Right) Source: Author**

Internally, Figure 1.10 (right), part (g), illustrates the domed hall of the historic mosque, which has been connected to two internal halls through the addition of a concrete slab to expand the

prayer space. Part (h) of the same figure shows the internal verandah of the old historic mosque, featuring the richly adorned interior previously discussed and depicted in Figure 1.7. However, the addition of these new structures, as shown in Figure 1.10, was carried out without consultation with experts, causing significant harm to and destruction of the mosque's internal beauty. The most critical concern is the impact these changes have had on the mosque's external visual appeal, particularly within the context of the historic monument complex. While the surrounding monuments have retained their spiritual legacy and visual integrity, the mosque's aesthetic and historical significance have been severely compromised, diminishing its value within the complex.

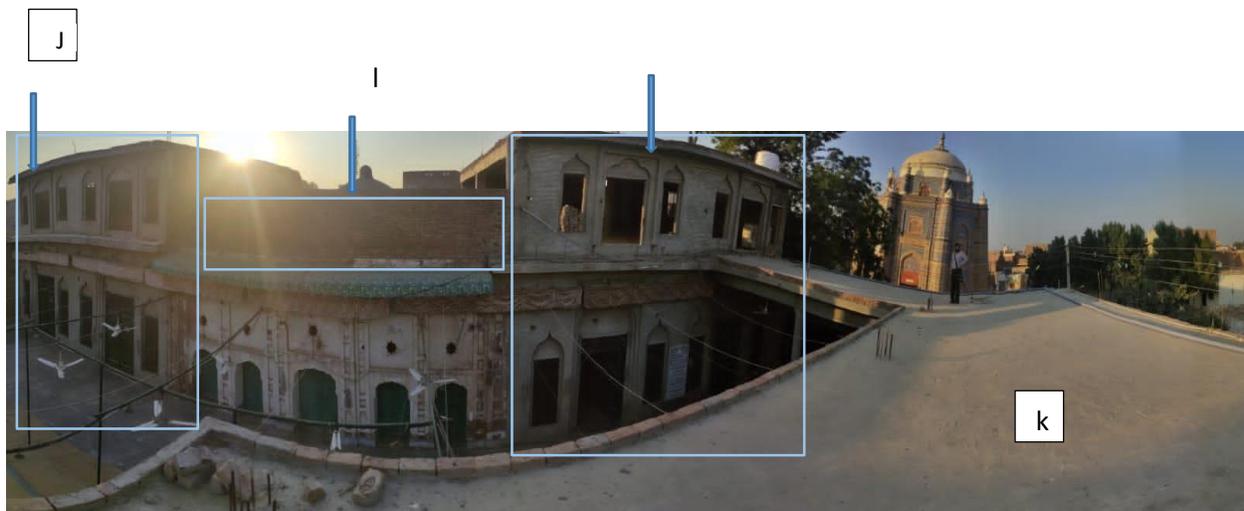
**Fig 1.11 Panoramic view of the Mosque, New Added Structures (Parti, j, k &l) Source: Author**

The addition of double-story structures, as shown in Figure 1.11, parts (i) and (j), has completely obstructed the view of the mosque from the outside. Standing within the complex, it is now impossible to perceive or appreciate this historic mosque from an external perspective. This demonstrates a complete disregard for the contextual significance of this historical monument, as its visibility and prominence within the complex have been entirely overlooked.

A small but impactful step toward restoration would involve removing the front parapet (Figure 1.11, part "l") located in the center of the mosque's structure, as it obstructs the view of the domes. Once this barrier is removed, the domes—still structurally intact—can be externally restored to their original form and appearance. Additionally, all new structures built within the mosque can be reassessed to ensure the monument's preservation. Notably, conserving the mosque's external elements would require a relatively modest budget while achieving significant results in restoring its historical grandeur.

In the long term, the removal of the newly added double-story structures on the north and east sides of the historic mosque is essential to enhance its visual prominence and restore its contextual integrity. This would allow the mosque to regain its historical grandeur and cultural significance. Furthermore, community knowledge-sharing and training programs are crucial to

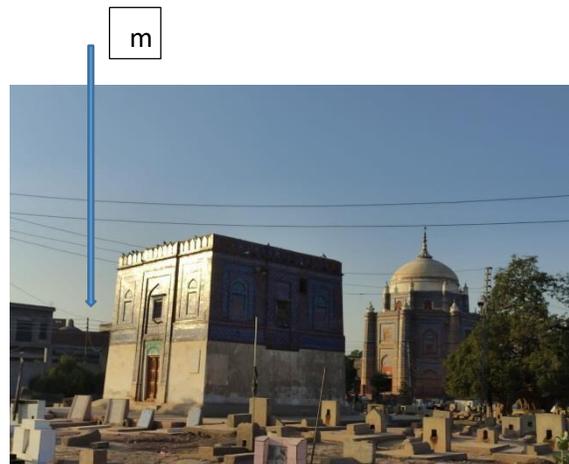
**Fig 1.12 New Added Parapet (Part m). Source: Author**

The external visual impact of the mosque's domes can still be partially appreciated from the eastern side of the mosque (Figure 1.12, part "m"). However, the decaying condition of certain internal elements, particularly at the arched doorways, requires immediate repair to prevent further deterioration. Conservation efforts should aim to restore each part of the mosque to its original form, preserving the historical legacy of this significant monument.
